HOME INSPECTION REPORT

***Address: Your Address
Anytown, NC
For: Demo Report
May 26, 2009***

RIGHT STEP HOME INSPECTIONS LLC

SUMMARY OF RECOMMENDED REPAIRS

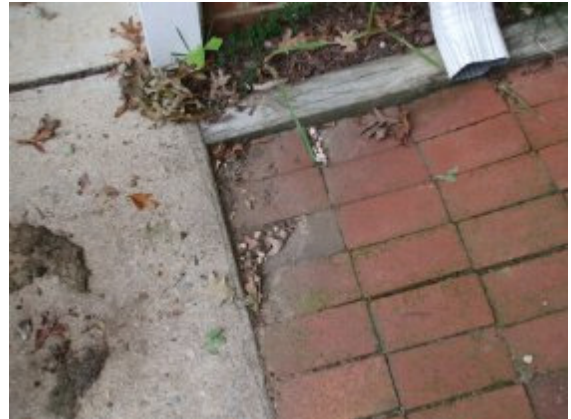
Where the brick sidewalk from the right side yard joins to the driveway at the right front of the garage, the pavers have settled approximately 1" and have become a trip hazard and also are causing water to settle at the foundation. The pavers should be raised and made level to the driveway to eliminate this hazard and to effectively drain water away from the house.

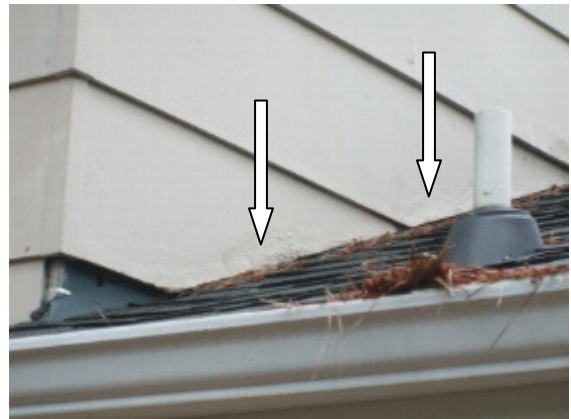
The hardboard siding has deteriorated on the second story where it comes in contact with the roof over the living room and kitchen. This has been caused by insufficient clearance between the siding and the roof shingles (at least 1" of clearance is needed). All siding along the roof line should be probed and all deteriorated siding replaced to prevent further damage to the siding and wall structure.

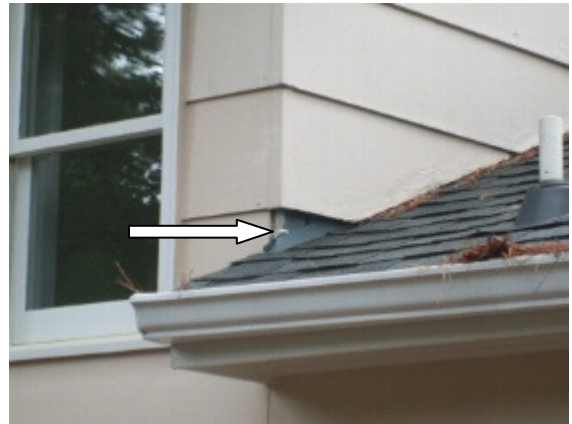
At the rear of the house where the lower corner of the roof meets the siding on the second story a small piece of siding is missing, exposing the wall structure to rain water. Siding should be installed to prevent water damage to the internal wall structure.

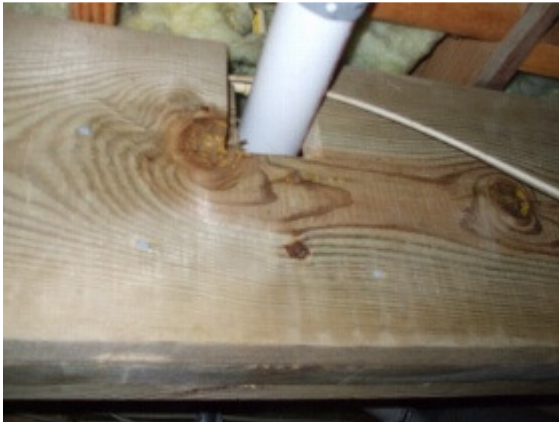
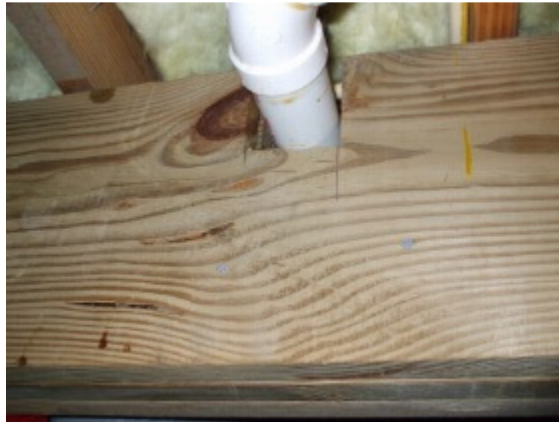
The top of the triple 2" x 12" wood beam in the storage room to the rear of the basement den area has been notched to allow for plumbing pipes. This has degraded the structural integrity of the beam. This should be repaired to prevent sagging in the floors above.

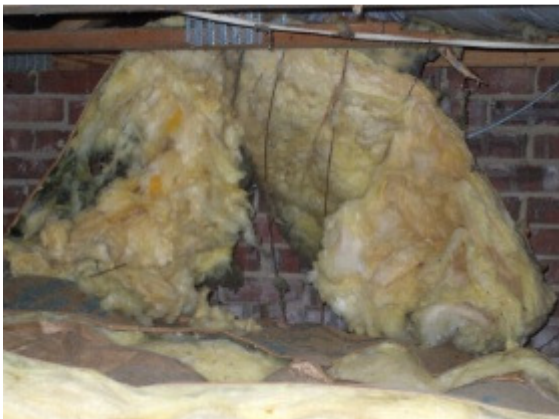
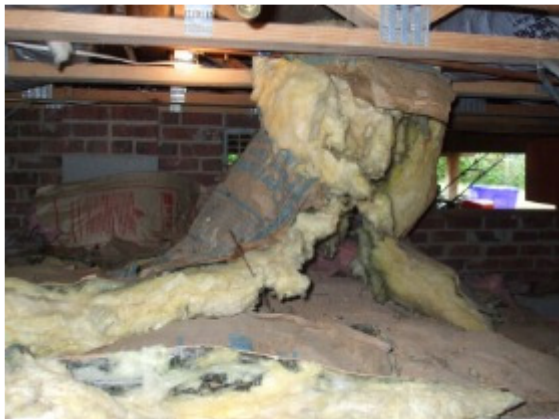
When entering the crawlspace it was noted that most of the fiberglass batt insulation has fallen from the floor structure, is lying on the ground and has become dirty and damp from ground moisture. All insulation on the ground should be removed from the crawlspace and discarded. New R19 batt insulation should be installed by an insulation contractor that is familiar with installing batt type insulation in a truss floor system.

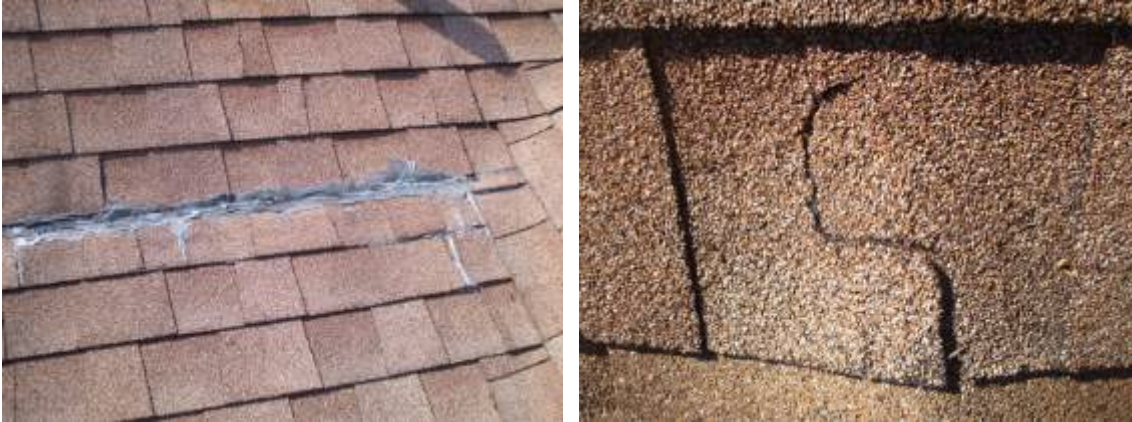
A - At the rear of the house to the left of the rear dormer the roofing has been repaired with roofing sealant and caulk. This was to repair a previous leak due to unevenness of the roof sheathing at the transition of the main roof to the roof over the rear sun room. The shingles in this area should be removed, the sheathing over the sun room should be properly let into the sheathing on the main roof and the shingles replaced.

B - When walking the roof, a cracked shingle was noted at the peak of the roof over the back porch. This has a high potential for causing a leak. This should be temporarily repaired with a roof caulking and then replaced when the roof is replaced.

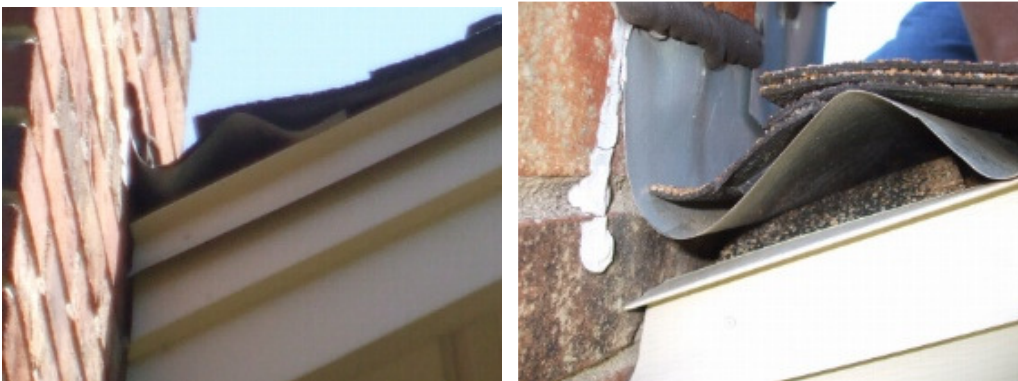
On the right side of the house to the rear of the chimney, the roof flashing is bent and which can allow rainwater to enter under the roof shingles and into the wall structure. This should be repaired to prevent further damage.

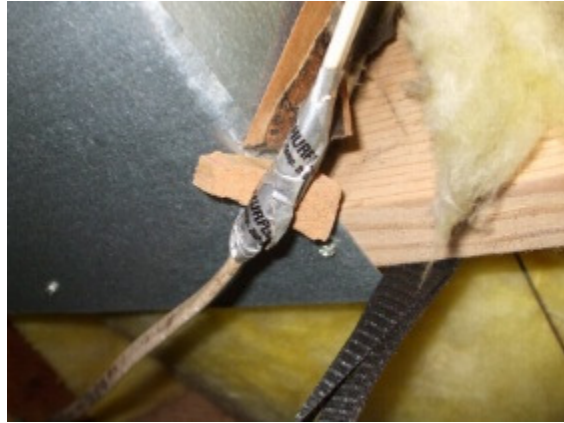
In the crawlspace there is a 110VAC line that has been run under a metal heat return duct. The line is too tight and has been insulated with tape and a small piece of wood. The tape and wood should be removed and if need be the line extended so it is not in contact with the metal to prevent an electrical shock and fire hazard.

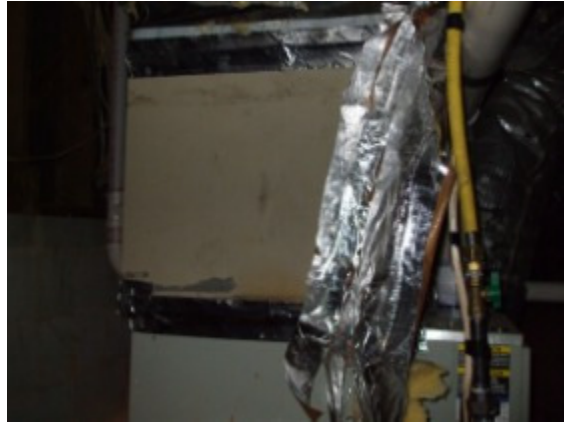
A - The insulation around the connection of the main distribution line to the furnace in the crawlspace has fallen down and should be replaced for energy efficiency.
